NORTON RESERVOIR DAM

MA 00815

PHASE I INSPECTION REPORT
NATIONAL DAM INSPECTION PROGRAM

AUGUST 1978

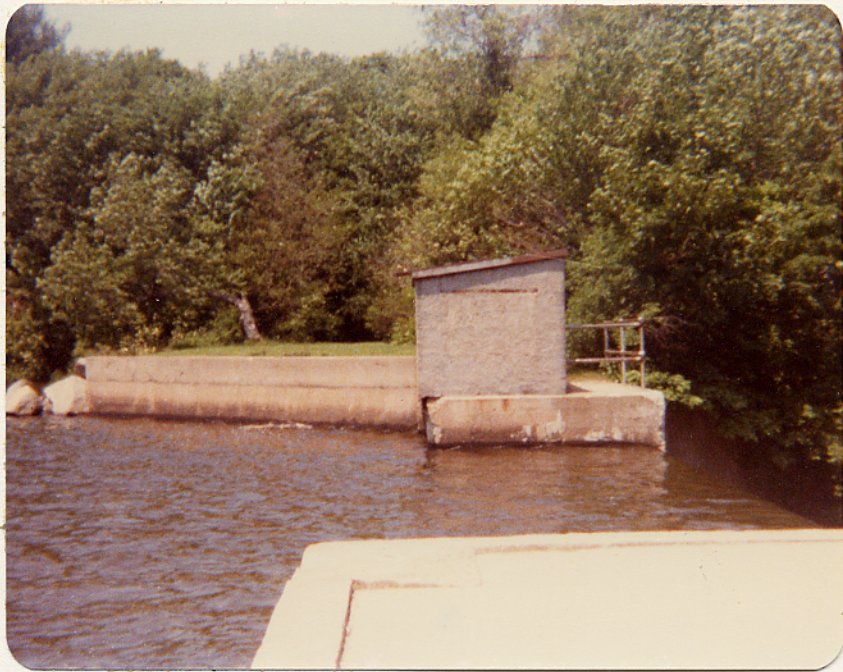
8

Left Abutment Looking Across Spillway

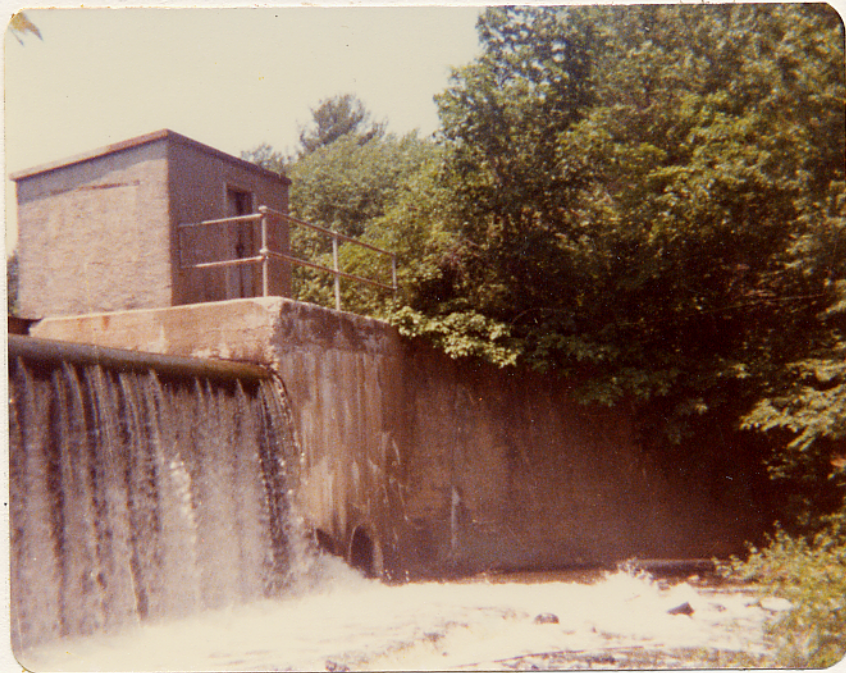
9

Left Abutment Looking Across Apron

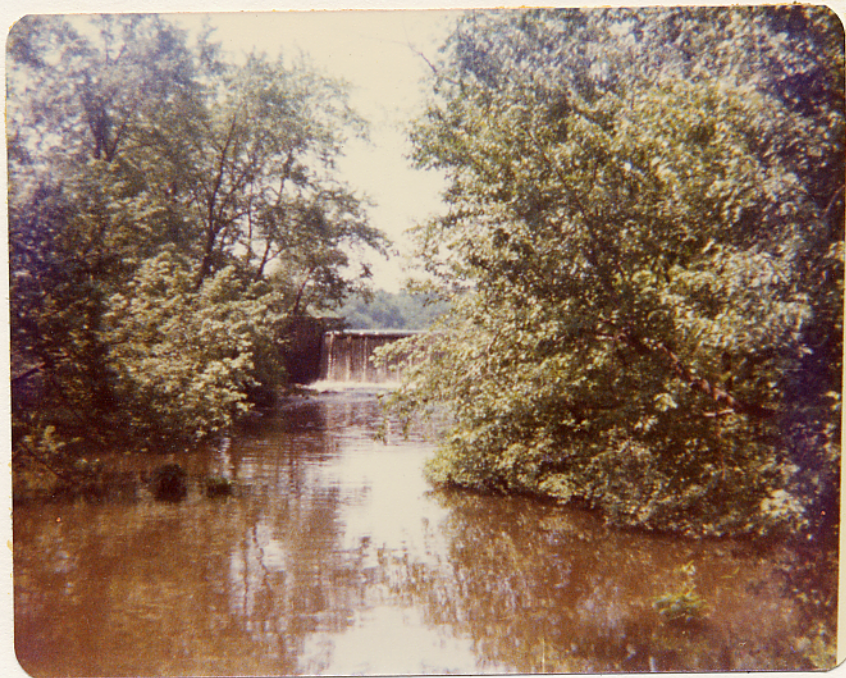
Downstream View of Dam

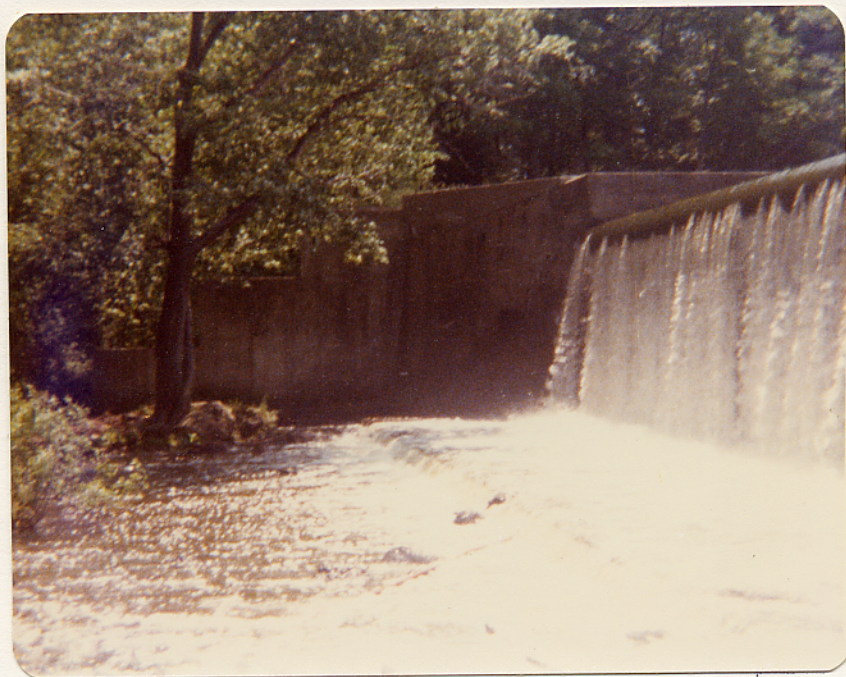
Right Bank Retaining Wall
looking Across Apron
